Analyzing the Corrosion Resistance of Ni-Shield 200 Coatings at Different Temperatures When Exposed to Sulphuric Acid

Industry Sponsor: Scoperta Inc.

Materials Engineering Department

California Polytechnic State University

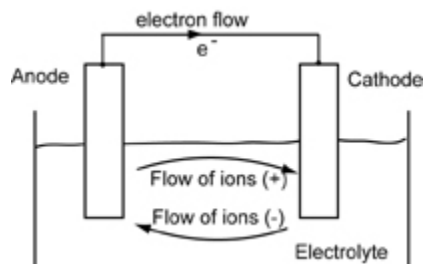
Figure 1: Basic galvanic corrosion cell, showing all 4 constituent parts ^[3]

There are many kinds of corrosion, but the most important is galvanic corrosion. Galvanic corrosion occurs when two different metals or the same metal with two different potentials are exposed to an electrolyte and are electrically connected (Figure 1). What this

All four elements (anode, cathode, electric circuit between them and ion path between them) work together to produce a basic corrosion cell. Negatively charged electrons removed at the anode can flow to the cathode, and positively charged ions at the anode can flow to the cathode. Even though matter is traveling from the anode to the cathode on both sides of the stream, since one flow is positively charged and the other is negatively charged, the two still combine into one circuit. This circuit has a current that can be measured in amperes, and is one way of representing a corrosion rate.^[6]

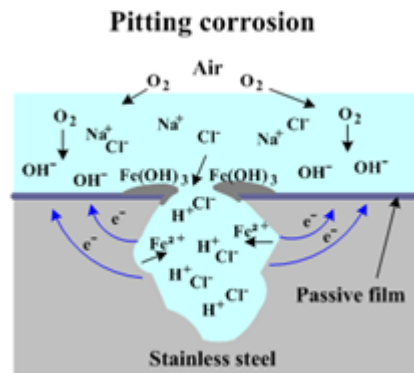
Figure 2: Diagram of pit on stainless steel, showing the different chemical reactions that occur ^[8]

The reason for this accelerated localized corrosion is because the area of the cathode is much greater than the area of the anode ^[9]. Since the overall current flow in both regions must be equal in order to maintain a circuit, this causes the current density (current/surface area) to be much larger at the anode than the cathode. Current density is directly proportional to the linear rate of corrosion at that location, as the only way to get current flow is to oxidize the metal into its ionic state. In order to sustain a large current density, more ions need to be formed over the same surface area, causing the corrosion to penetrate much deeper into the material than if it was spread out over a larger area.

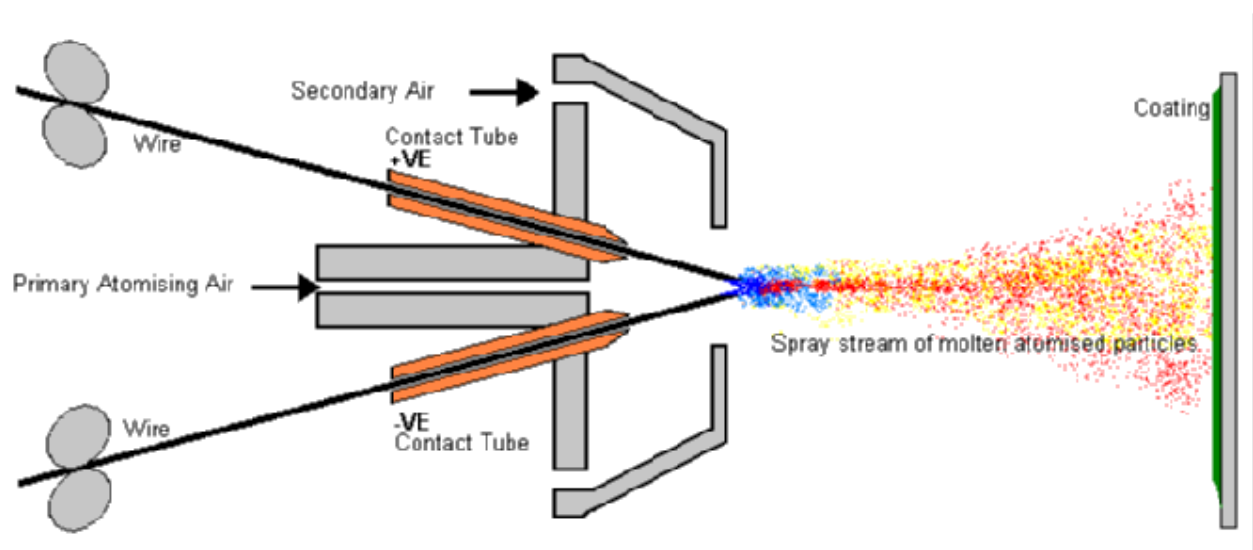
Figure 3: Schematic of the Arc Wire Thermal Spraying, showing all the steps required to melt and spray the material ^[12]

One method of spraying the coating on is called twin wire arc thermal spraying (Figure 3). In this method, two wire forms of the coating are charged oppositely and then brought close together. Once close enough, the electrical potentials between them become strong enough to where electrical arcs form between the two wires. This heats up the metals enough to melt them, and then air is blown in to push the melted droplets onto the surface, where they cool and solidify as a coating.

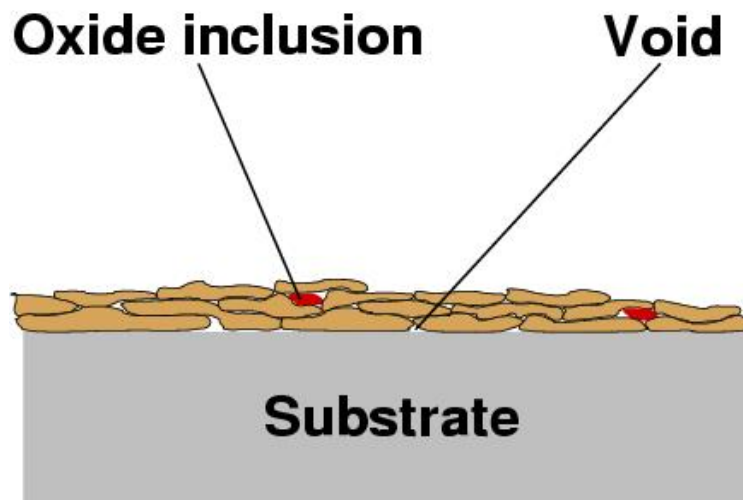
Figure 4: Schematic of the problems with thermally sprayed coatings ^[13]

While this method does adequately coat the material, there are a number of problems with it. Because of how the coating is applied, it is usually uneven (Figure 4), which is both inefficient and potentially dangerous for pitting corrosion. There are also voids and oxide inclusions, which reduce the strength of the coating and create potential differences that can create a corrosion cell in the alloy.

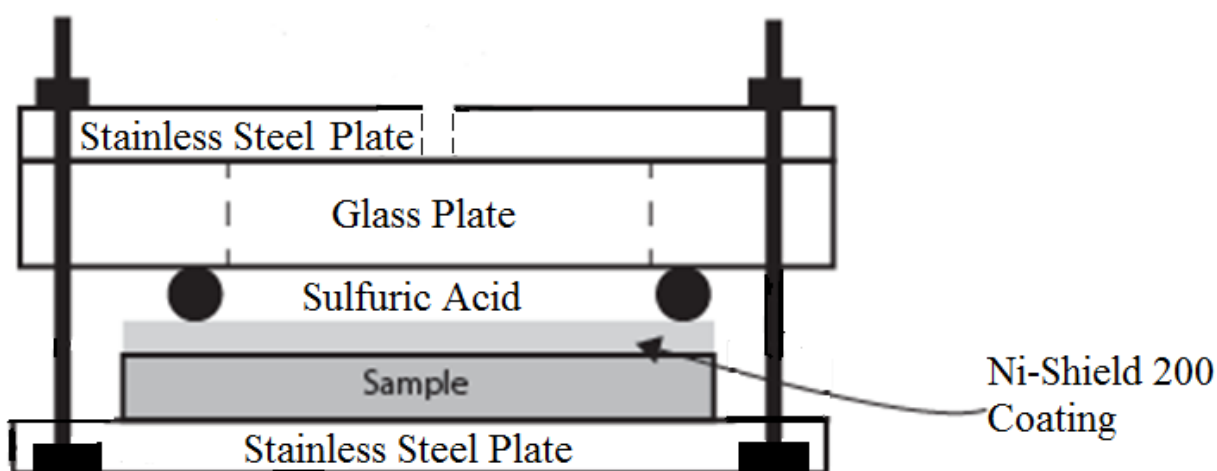
Figure 5: Schematic of the Jig Used

acid would likely attack the substrate at a different rate than the coating, thus rendering the results useless. Instead, I was able to construct a jig that would expose only one side of the metal to the corrosive environment, with the acid being contained by an O-ring seal (Figure 5).

This jig works in a simple way. The bottom panel is a 3/8" X 4" X 4" stainless steel plate. It has four holes counter-bored into the bottom face for 1/4" hex bolts, one at each corner. This allows the plate to sit flat on top of a hot plate, exposing the maximum surface area to allow for a more even heating of the sample and the acid. On top of this plate is a 3" by 3" by 1/4" sample coated on one face with the Ni-Shield 200 coating about 500 μm thick. The sample is rotated 45° from the orientation of the base stainless steel plate to fit better on top of it. Next, a 1 7/8" outer-diameter brown Viton fluoroelastomer o-ring is placed on top, in the approximate middle of the sample. This would be directly on top of a circular polish on the coating surface, done with a 2" diamond carbide grit hole saw, in order to achieve a good seal between the o-ring and the otherwise rough as-received surface. On top of this o-ring is a 3" by 3" by 3/4" glass

plate, with a 1 ¾" hole cut in the middle. The purpose of this plate is to increase the reservoir of acid in contact with the sample. On top of the glass plate is another stainless steel plate, the same size as, and aligned with, the bottom one. This plate has one ¼" hole drilled in each corner that lines up with the holes drilled into the bottom plate, and one 3/8" hole drilled in the center. The 3/8" hold is to provide an opening to add and remove the acid by pipette. All the parts are shown below disassembled (Figure 6), partially assembled (Figure 7) and assembled (Figure 8). I used four of these jigs at any one time, and all four were identical. Once assembled, the jigs were placed in a fume hood for safety.

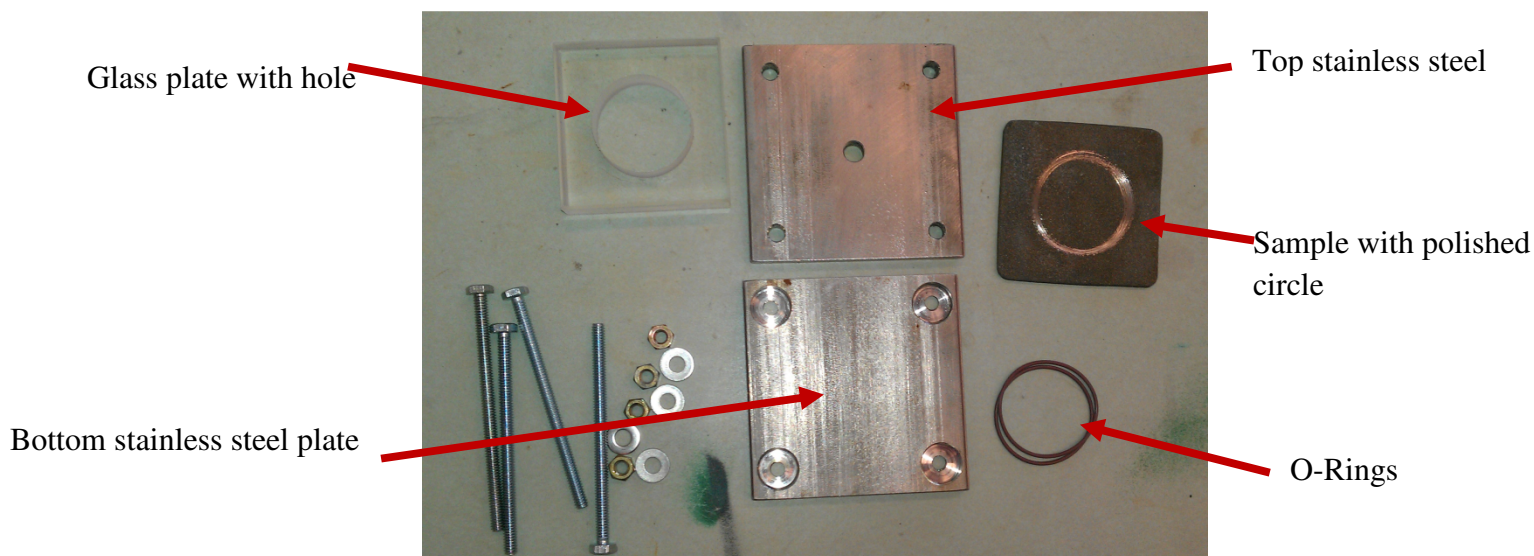
Figure 6: All the components to one jig are laid out side-by-side

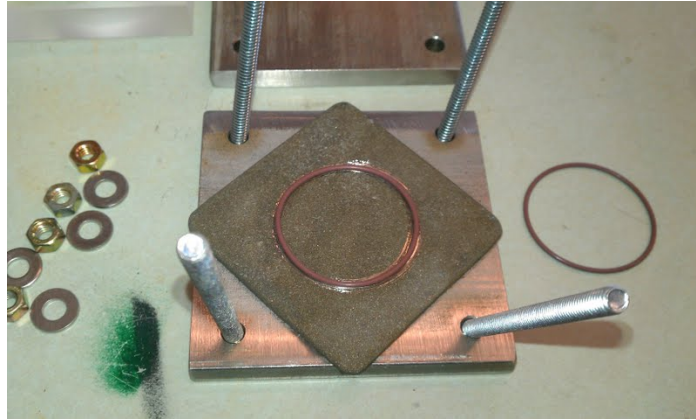
Figure 7: The bottom stainless steel plate, along with the hex bolts, sample and first o-ring are shown in this partially-assembled jig

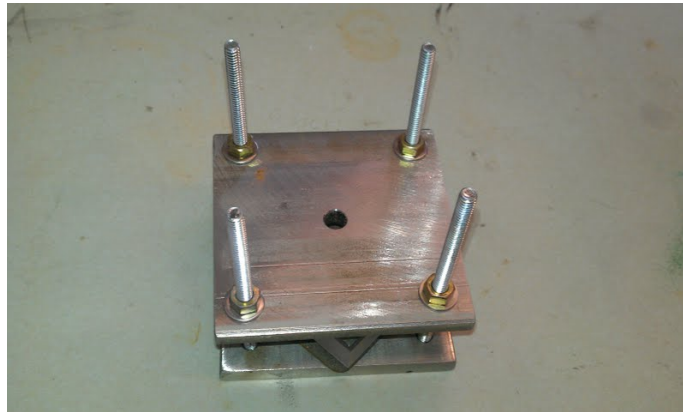
Figure 8: This is a picture of the fully assembled jig, with the hole on top where acid is added and removed visible

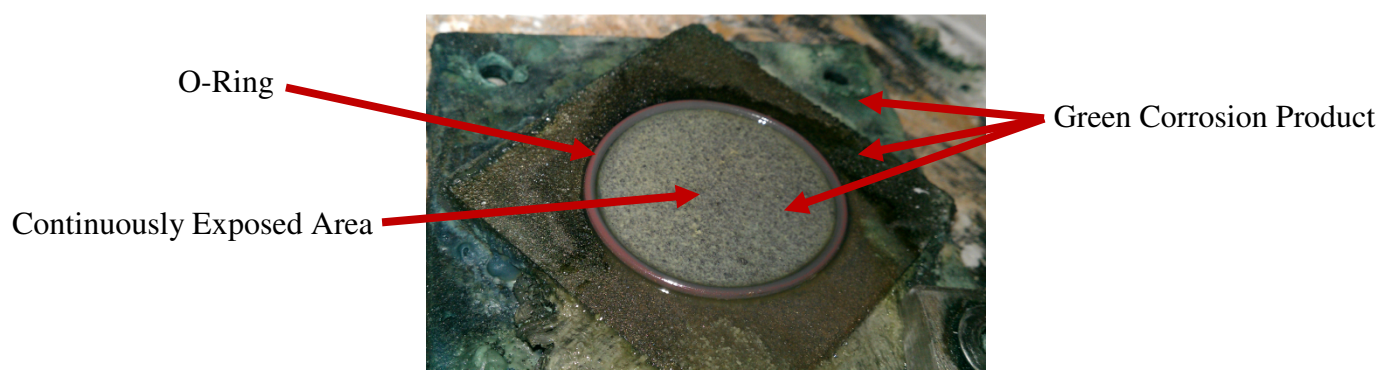
Figure 9: 100°F sample showing green corrosion product outside the continuously exposed area and the lighter green color inside the continuously exposed area

The most immediate observation was that there was a buildup of corrosion product on the surface of the samples before cleaning. This product was only present on the Ni-Shield 200 coated samples, and is different depending on the testing temperature. For the room temperature and 100°F samples, this product was green and relatively thick (Figure 9). This product looked to be similar in nature to the more solidified green substance on the edges of the jig, only less concentrated, resulting in a lighter green color.

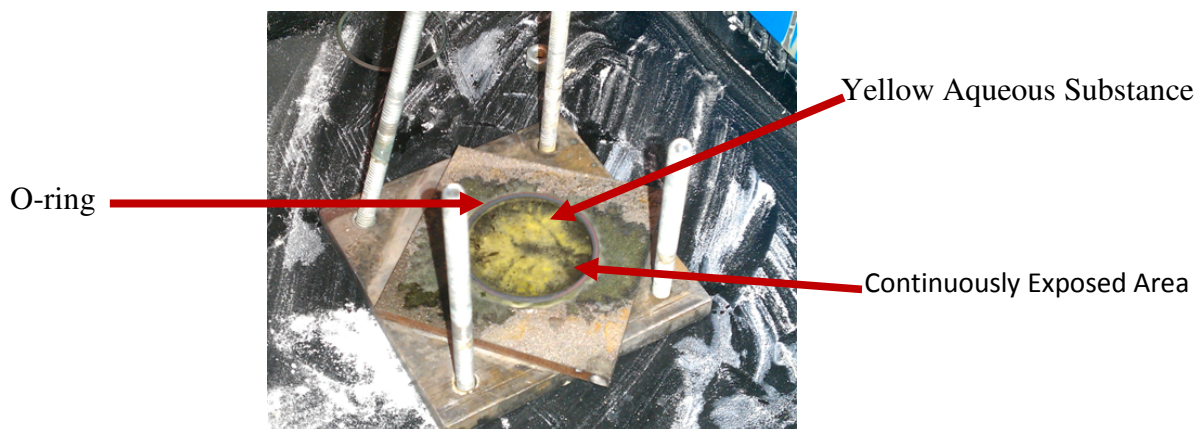
Figure 10: 200°F sample showing yellow substance concentrated in the continuously exposed area. The area outside the O-ring originally was in contact with acid but it dried up during testing

On the other hand, on the 200°F samples, the substance is yellow and aqueous (Figure 10). It appears in roughly the same places as the green corrosion product does on the lower temperature samples, though it is more concentrated in the continuously exposed area.

Also, both substances could be washed off with acetone or water. I was not able to determine the chemical composition of these compounds due to time and material constraints, though since the samples were exposed to concentrated sulfuric acid, the yellow substance is most likely some form of concentrated sulfur.

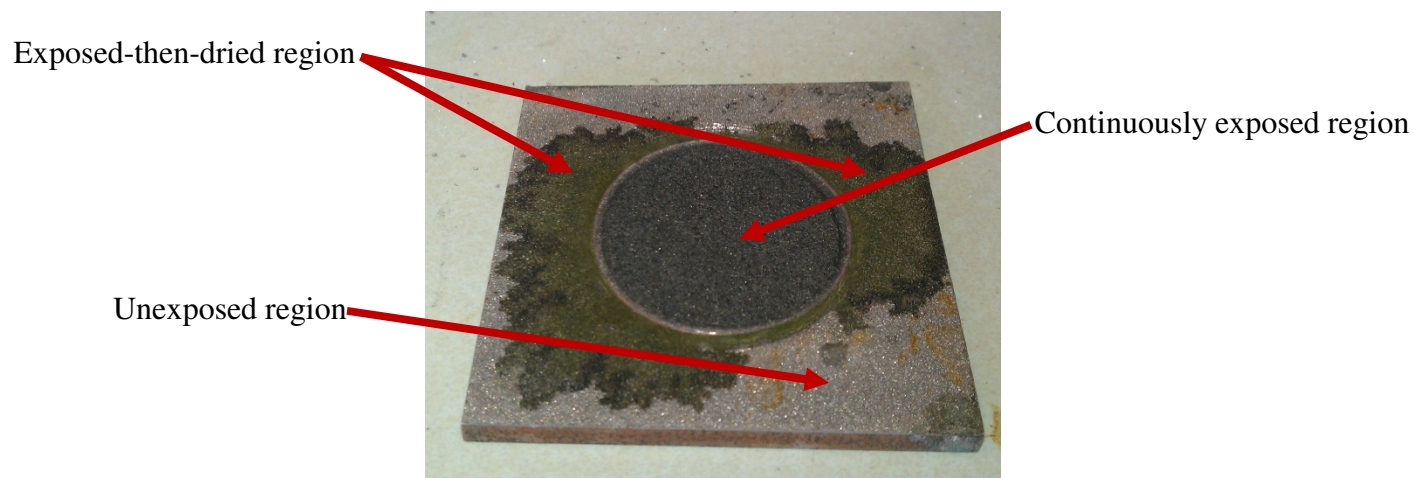
Figure 11: Cleaned 200F Ni-shield sample showing three distinct regions—the continuously exposed center, the unexposed outer edges, and the exposed-then-dried regions in between

Looking at the cleaned samples, there is also significant macroscopic evidence of a corrosion reaction on the Ni-shield 200 samples regardless of temperature (Figure 11). There is a clear color and texture difference between the three regions, indicating that exposure to concentrated sulfuric acid had a lasting effect on the coating.

The constantly exposed area in the middle circle is a different color than the unexposed areas around the edges. The black-yellow compound between these two sections is where acid leaked out but eventually dried up. This sort of coloration is not present on the Hastelloy C-276 samples (Figure 12), where there is almost no difference between the exposed and unexposed sections.

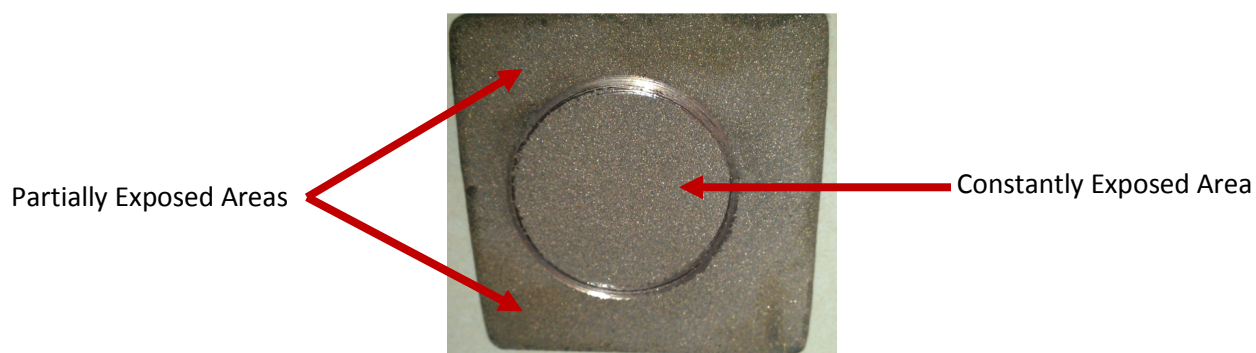
Figure 12: Cleaned Hastelloy C-276 sample after 1 week of acid exposure. Unlike the Ni-Shield 200 samples, there was little if any visual difference between the exposed and unexposed regions.

As for the Hastelloy C-276 sample, while there was no immediately obvious corrosion product, the microstructure was similar enough to the Ni-Shield 200 sample that I cannot say that there was no corrosion reaction. It is entirely possible that the corrosion reaction was just less macroscopically obvious. Like the Ni-Shield samples, the microstructure showed more potential

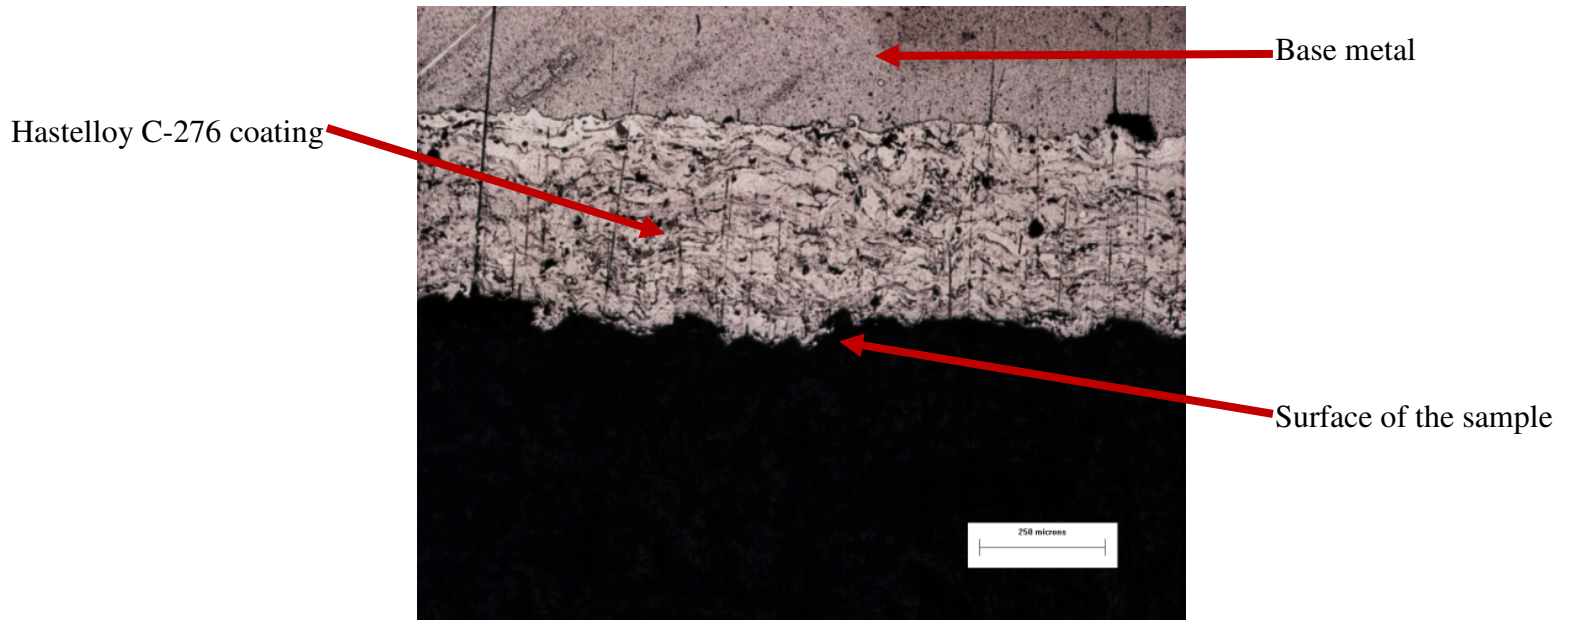
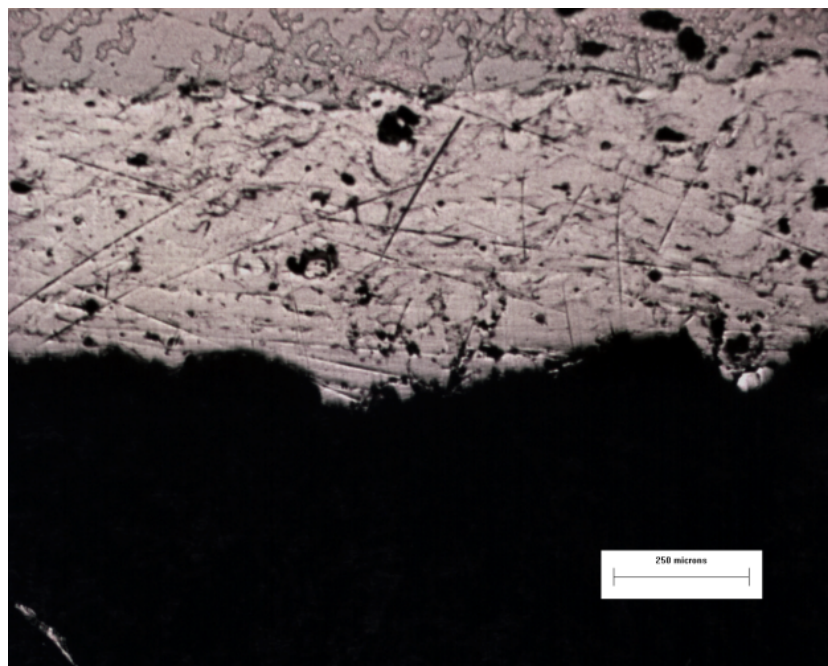
Figure 13: Hastelloy C-276 As-received 50X unetched

Figure 14: Ni-Shield 200 as-received 50X unetched

Finally, I looked at a section of the coating with an optical microscope in order to identify any localized corrosion occurring on the surface and look to see if there was any penetration of the coating towards the base material. I did this by comparing the as-received samples (Figures

For both coating alloys, there is a clear difference between the tested and as-received samples, mostly related to how the surface looks. In both coatings, the as-received surface is much smoother than in the tested surfaces, though this is clearer in the room temperature Ni-

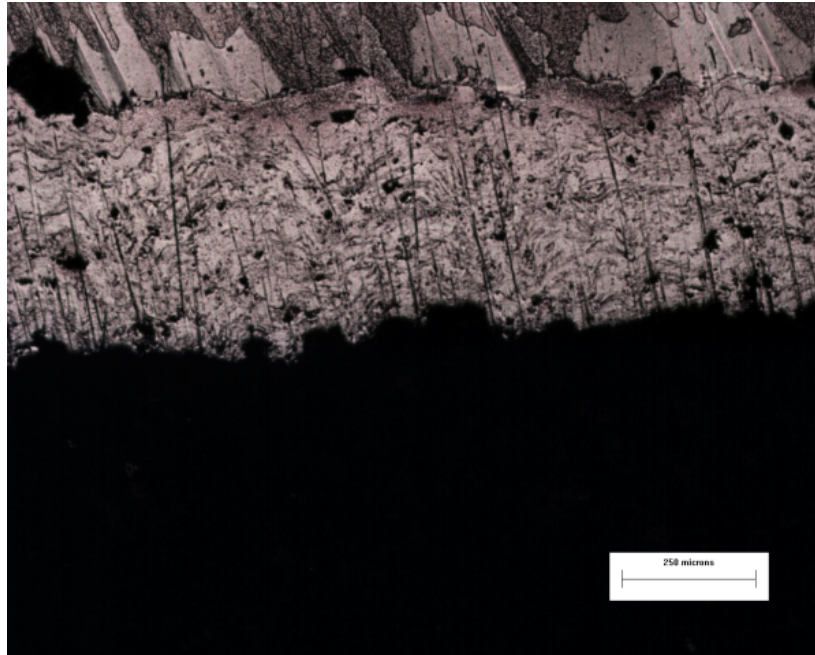
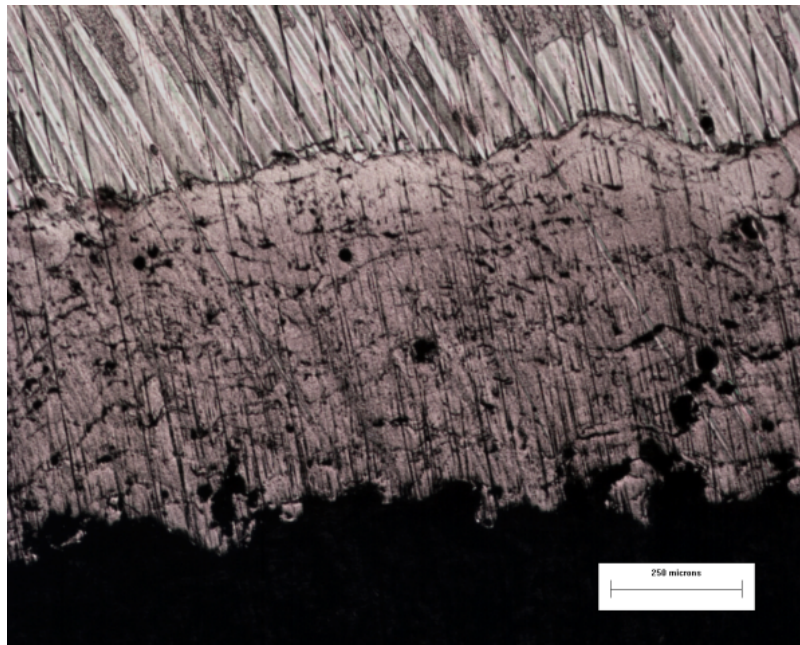
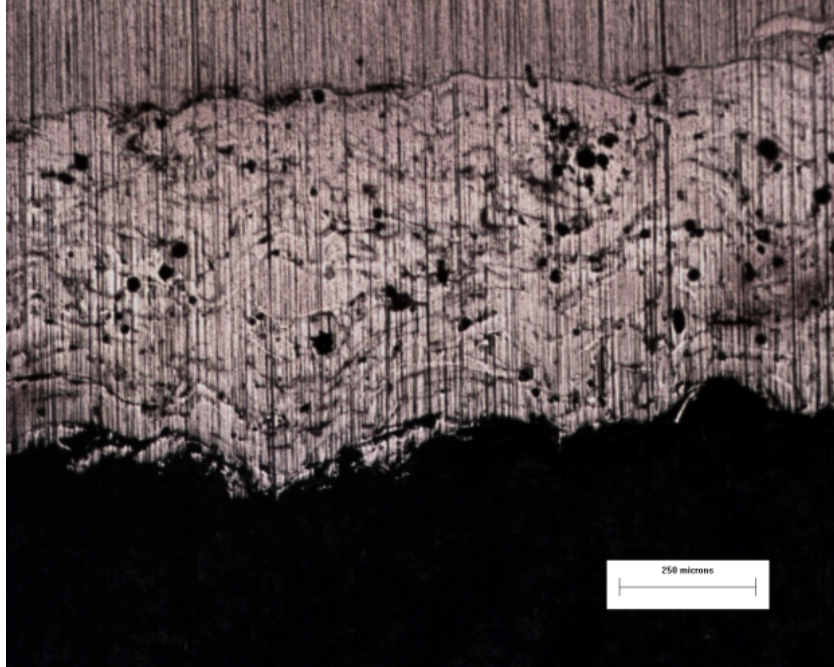
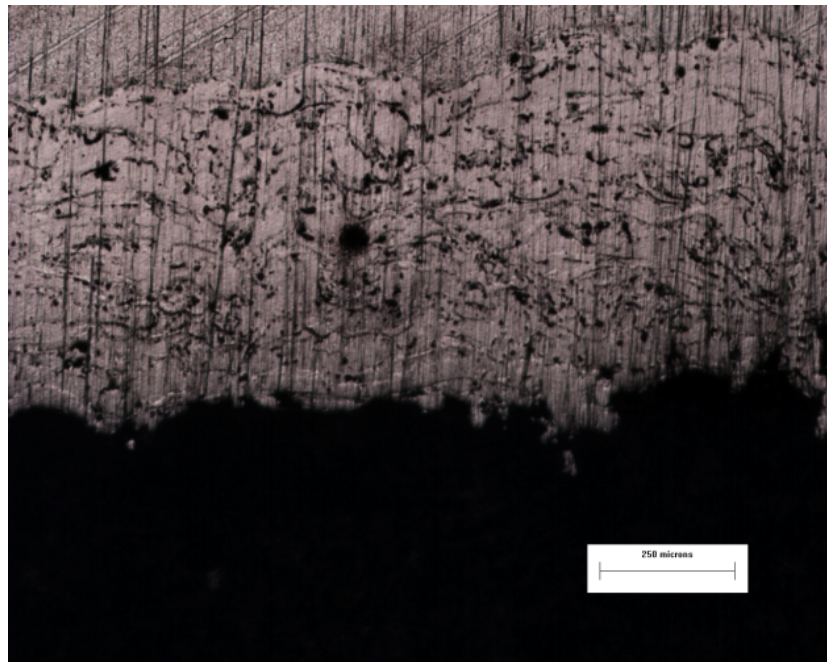
Figure 15: Hastelloy C-276 2 weeks 98% RT 50X unetched

Figure 16: Ni-Shield 200 2 Weeks 98% RT 50X unetched

Figure 17: Ni-Shield 200 2 Weeks 98% 100F 50X unetched

Figure 18: Ni-Shield 200 2 Weeks 98% 200F 50X unetched

Shield 200 samples than for the elevated temperature ones. None of the samples showed any signs of deeper coating penetration.
